# *Troubleshooter Guide*

***RENOLD***

The Renold Troubleshooter highlights a series of common failure modes to give maintenance engineers an insight into the effects of application conditions and the benefits of installation and maintenance best practice.

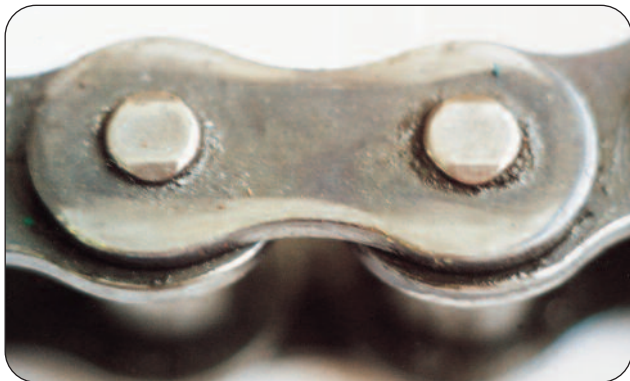
**Figure 1 - Mode of Failure - Alignment**

| Application | Simple transmission chain drive. |
|---|---|
| <b>Failure Mode:</b> | Rubbing wear on the face of the side plates, the end of the side plates and the pin end. |
| <b>Diagnosis:</b> | The chain has been rubbing against some fixed point on the circuit. This may have caused damage to parts of the guide system or fixtures. |

| Application | Simple transmission chain drive. |
|---|---|
| <b>Solution:</b> | Realign the chain drive before the damage to the chain becomes too serious and the chain has to be scrapped. |

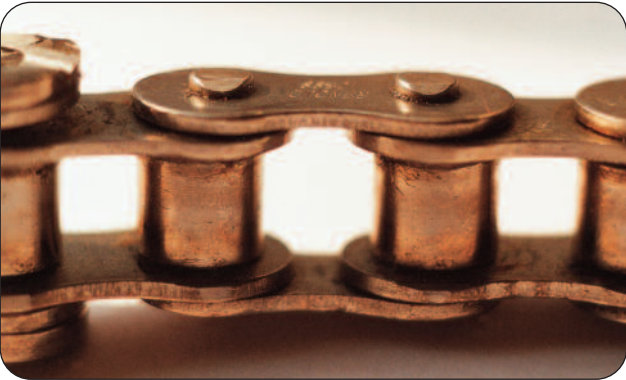
**Figure 2 - Mode of Failure - Abrasion**

| <b>Failure Mode:</b> | The chain suffered rapid pin/bush wear and pitch extension. |
| <b>Diagnosis:</b> | When the oil at the delivery end of the fryer was examined, it was found to contain product residue that had been degraded to form very hard burnt particles, that were abrading the chain round parts. |

| <b>Solution:</b> | Fit replacement chain and introduce a filtration system to the cooking oil to remove the abrasive residue. |

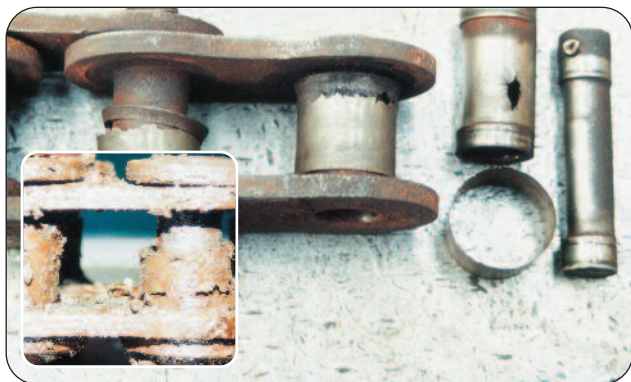
**Figure 3 - Mode of Failure - Corrosion**

| <b>Failure Mode:</b> | Heavy corrosion and erosion of all parts. |
| <b>Diagnosis:</b> | Bush and rollers have corroded / worn to a wafer thin condition with corresponding wear on the pins. Plates have a great deal of side wear and are heavily pitted. This chain has been used in an extremely hostile environment subject to high temperatures and water spray. |

| <b>Solution:</b> | Improve lubrication methods.<br>Consider using a corrosion resistant chain. |

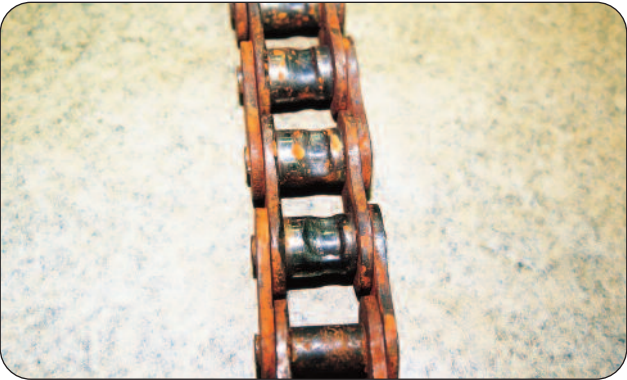
**Figure 4 - Mode of Failure - Corrosion**

| <b>Failure Mode:</b> | Corrosion. |
| <b>Diagnosis:</b> | This chain has been used in an environment with water contamination. The chain has not been regularly lubricated and external parts have gradually corroded until the rollers seized. The chain has then proceeded to wear heavily on the rollers. |

| <b>Solution:</b> | Protect from water if possible. Increase degree of maintenance lubrication. |

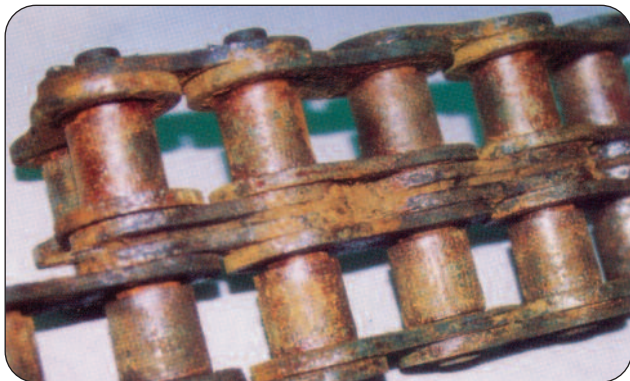
**Figure 5 - Mode of Failure - Corrosion/Erosion**

| <b>Failure Mode:</b> | Heavy corrosion of all the components in the chain. |
| <b>Diagnosis:</b> | The chain had been operating without any lubricant being applied and was also subject to attack by acidic sugar juice. As a result the chain suffered heavy corrosion and wear. |

| <b>Solution:</b> | Replace the chain and ensure adequate lubrication is applied. Protect the chain from juice with an appropriate casing. |

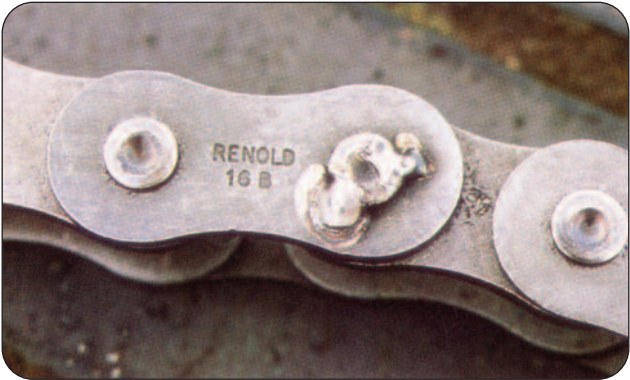
Figure 6 - Mode of Failure - Cracking

| Failure Mode: | Outer plate cracking |
| Diagnosis: | A pin has been tac-welded on both sides of an outer plate. The cooling rate after welding resulted in the plate cracking. |

| Solution: | No welding should be carried out after supply as this can cause plate cracking, distortion and stress relieving. |

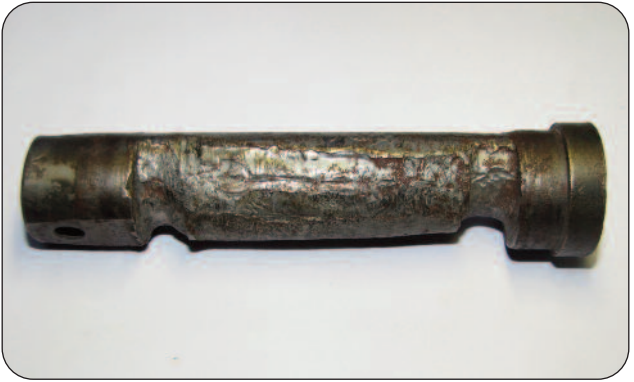
**Figure 7 - Mode of Failure - Erosion**

| <b>Failure Mode:</b> | Dry cavitation erosion caused by particulate debris |
| <b>Diagnosis:</b> | Pin erosion when handling dry materials which act like a fluid when in contact with the chain, this type of wear is common on elevator chain handling cement. |

| <b>Solution:</b> | Once the wear pockets are established the rate of wear tends to accelerate. Sealed joint chains are recommended to increase the chain life. |

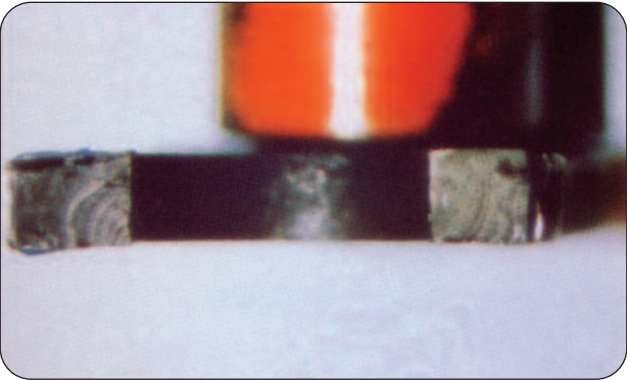
Figure 8 - Mode of Failure - Fatigue

| Failure Mode: | Inner plate suffered a fatigue failure. |
| Diagnosis: | Due to the high impulsive loading, a crack started at the edge of the plate hole and crack propagation occurred, resulting in a 'classic' fatigue failure. |

| Solution: | Eliminate high impulsive loading or select larger pitch chain. |

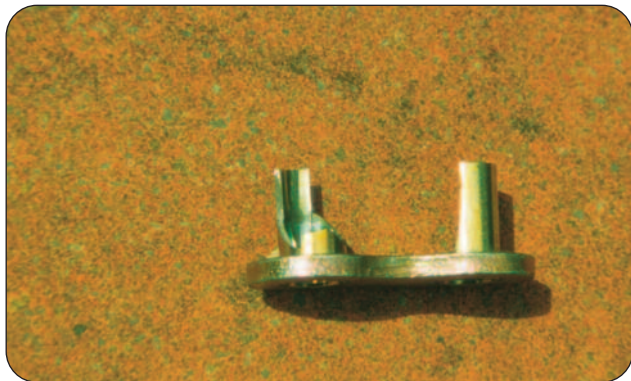
**Figure 9 - Mode of Failure - Fracture**

| <b>Failure Mode:</b> | Bushes fractured on assembly |

| <b>Solution:</b> | Ensure correct de-embrittlement treatment is carried out immediately after plating. |

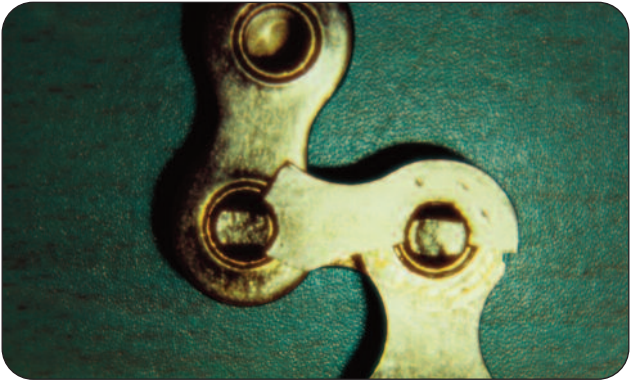
**Figure 10 - Mode of Failure - Fracture**

| <b>Failure Mode:</b> | Plates fractured when chain working load was applied. |
| <b>Diagnosis:</b> | Chain had been zinc plated by customer without carrying out any de-embrittlement treatment which resulted in chain failure due to hydrogen embrittlement. |

| <b>Solution:</b> | Chain should be initially zinc plated before assembly by Renold. |

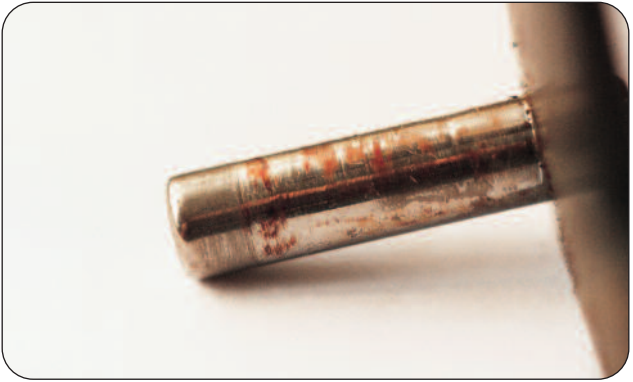
**Figure 11 - Mode of Failure - Fretting Corrosion**

| <b>Failure Mode:</b> | Severe wear of one pin of the pusher attachment and red deposit indicating fretting corrosion. |
| <b>Diagnosis:</b> | The pusher attachment was designed 50.8mm pitch to fit on a chain of 25.4mm pitch and operate on sprockets designed for 25.4mm pitch chains. This caused very high pressure on one pin of the attachment link which squeezed out most of the lubricant. This resulted in the marginal lubrication situation required to produce fretting corrosion. |

| <b>Solution:</b> | <ol style="list-style-type: none"><li>1. Use specially designed sprocket teeth with relieved tooth pocket at the attachment position.</li><li>2. Employ a high performance lubricant with solid residue to prevent squeeze-out.</li></ol> |

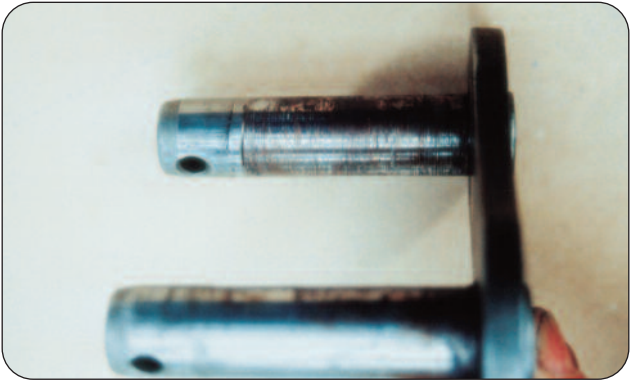
**Figure 12 - Mode of Failure - Galling**

| <b>Failure Mode:</b> | The bearing areas have suffered galling where the surfaces have articulated and then fused together. |
| <b>Diagnosis:</b> | Very high bearing pressures had been experienced in this lifting application. The effect being that the lubricant had failed and galling had occurred on articulation. |

| <b>Solution:</b> | Use a high quality, high pressure lubricant and ensure that a film of lubricant is maintained between mating surfaces. |

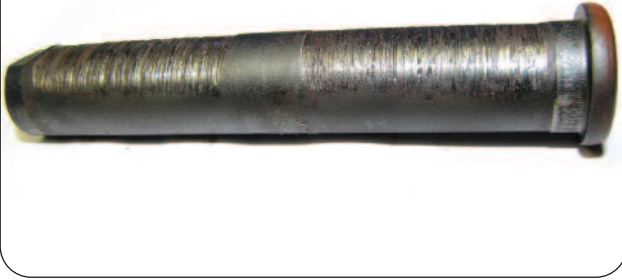
**Figure 13 - Mode of Failure - Galling**

| <b>Failure Mode:</b> | Severe galling due to high bearing pressures and lack of lubrication between articulating surfaces resulting in surfaces fusing together. |
| <b>Diagnosis:</b> | Lubrication failure resulted in surfaces fusing together under high bearing pressure. This galling process is also referred to as 'micro welding'. |

| <b>Solution:</b> | Ensure adequate means of lubrication. |

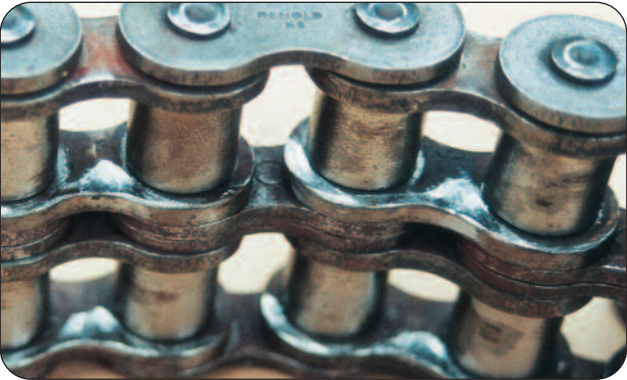
**Figure 14 - Mode of Failure - Lubrication & Alignment**

| <b>Failure Mode:</b> | Excessive wear. Chain jumping teeth causing tooth rounding. |
| <b>Diagnosis:</b> | Examination of the chain showed no lubrication had been applied in the 6 months service life. The loads involved require a minimum of oil sump lubrication. In addition to this the centre distance was higher than recommended and the sprockets were out of line. |

| <b>Solution:</b> | Improve the lubrication method. Consider hardening the driver teeth. Correct the drive alignment. |

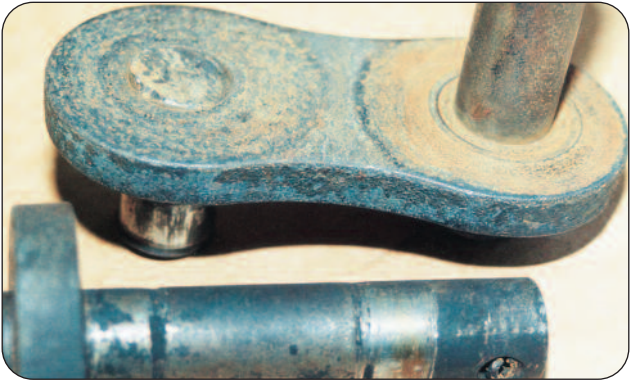
**Figure 16 - Mode of Failure - Lubrication & Alignment**

| <b>Failure Mode:</b> | Slip fit connecting link pin suffered a fatigue failure. |
| <b>Diagnosis:</b> | The joint was extremely dry and showed no signs of lubrication. The joint showed heavy galling with the presence of surface corrosion products. Subsequent investigation revealed that the chain had been running in water, but more significantly that the user had opened out the holes on the loose plate of the No 58 joint to make assembly easier. This caused the fatigue failure experienced. |

| <b>Solution:</b> | Provide a better lead in on the pin to enable the user to assemble more easily.<br>Reconsider lubrication regime. |

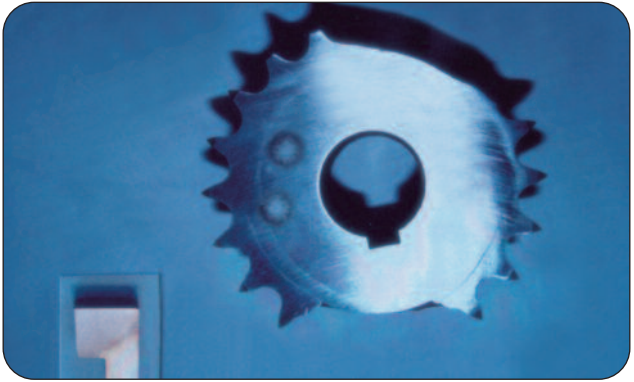
**Figure 17 - Mode of Failure - Material cracking below teeth**

| <b>Failure Mode:</b> | Material cracking below teeth. |
| <b>Diagnosis:</b> | Customer had flame hardened the teeth incorrectly. Due to the differential rate of cooling resulting from the sprocket section, cracking occurred. |

| <b>Solution:</b> | Sprockets to be supplied with teeth already flame hardened by Renold. |

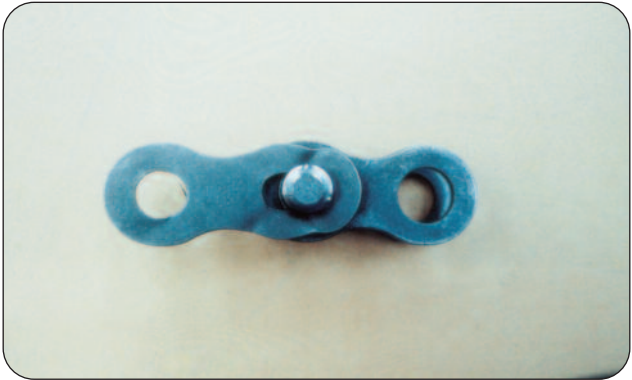
Figure 18 - Mode of Failure - Overload

| Failure Mode: | Outer plates have been permanently stretched due to the high load. |

| Solution: | Correctly size the chain for the application. |

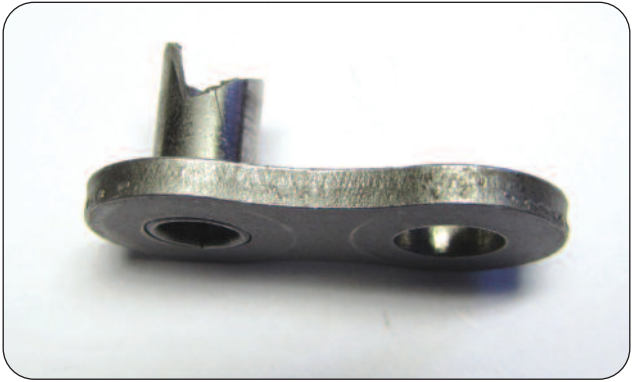
**Figure 19 - Mode of Failure - Overload**

| <b>Failure Mode:</b> | Severe damage to transmission chain pin and collapse of the chain bush. |
| <b>Diagnosis:</b> | Bush fatigue failures occur as the result of service overloads. The crack originates at a point on the inside surface of the bush and it progresses longitudinally or circumferentially until it cracks completely. Failures may also be caused by improper sprocket manufacture or selection. |

| <b>Solution:</b> | Bush fatigue can be overcome by eliminating overloads, increasing sprocket size and changing sprockets that are badly worn or oversized on the bottom diameter. |

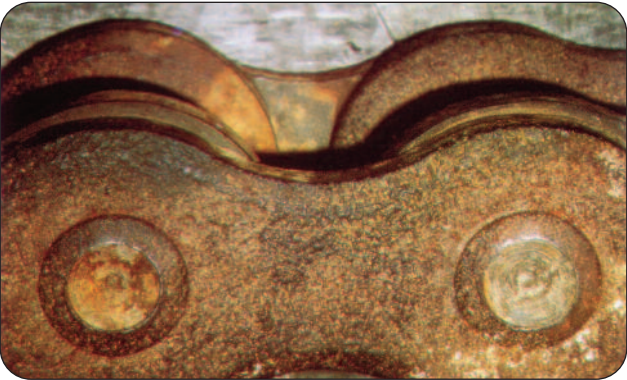
**Figure 20 - Mode of Failure - Pitting Corrosion**

| <b>Failure Mode:</b> | Severe damage to transmission chain pin and collapse of the chain bush. |
| <b>Diagnosis:</b> | Excessive overload on the chain led to the collapse of the bush and damage to the pin. |

| <b>Solution:</b> | Correctly size the chain for the application. |

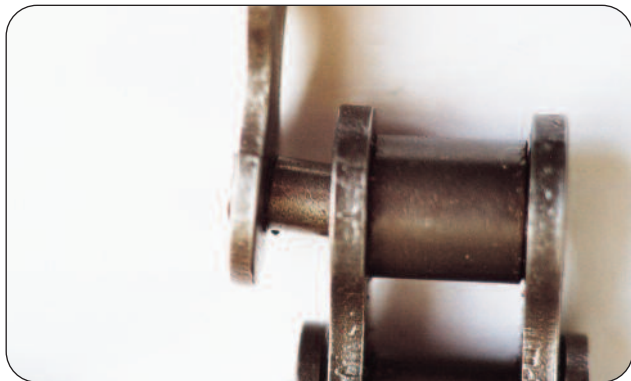
**Figure 21 - Mode of Failure - Riveting Failure**

| <b>Failure Mode:</b> | One outer link has become detached and the pin bent. |
| <b>Diagnosis:</b> | The loose side plate of a No 107 connecting link has become detached due to inadequate riveting on site. The pin has moved out and jammed in position allowing the chain to continue working until the failure was noticed. |

| <b>Solution:</b> | Replace the No 107 link and ensure that the pins are adequately riveted. |

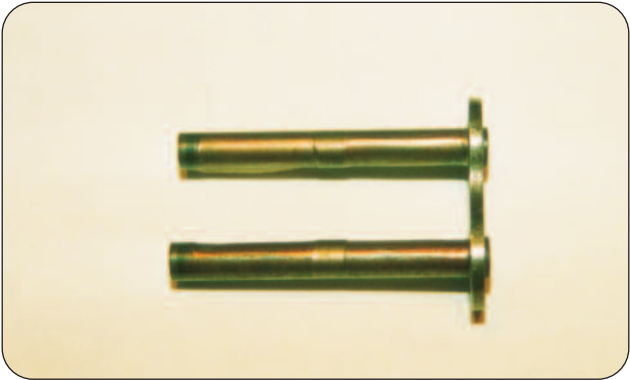
Figure 22 - Mode of Failure - Wear

| Failure Mode: | Pin bearing areas worn. Note position of intermediate plates is clearly visible. |
| Diagnosis: | Over a long period of time the pins have gradually worn until the chain elongation has reached 2% |

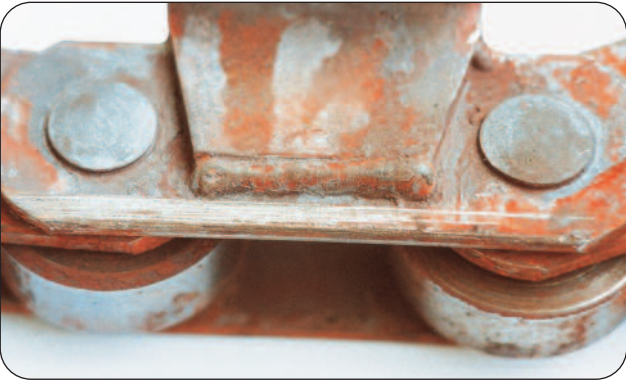
**Figure 23 - Mode of Failure - Alignment**

| <b>Failure Mode:</b> | Side plates showed severe rubbing marks along one edge. |
| <b>Diagnosis:</b> | The side plate edges have been rubbing against some fixed point on the conveyor structure, probably the edge of the guide tracks. The effect of this would be to wear away the side plate and to increase the drive power and chain tension. |

| <b>Solution:</b> | Determine the point of contact and realign the chain to prevent rubbing. It may be necessary to check and adjust the track to ensure levels are correct across the two strands. |

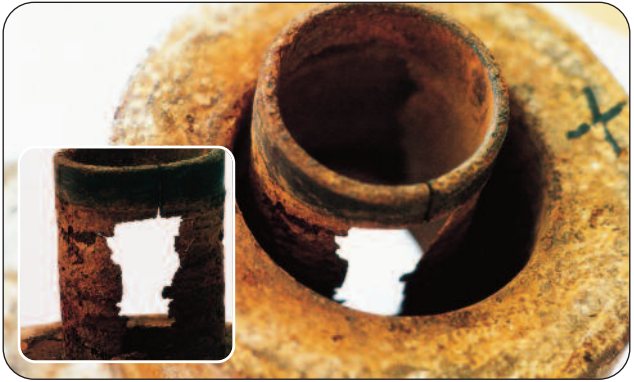
**Figure 24 - Mode of Failure - Abrasion**

| <b>Failure Mode:</b> | Severe wear between the chain bush and roller in a china clay extraction plant. |
| <b>Diagnosis:</b> | Abrasive residues (Quartz) in the clay from the original granite material causing wear to the surfaces. |

| <b>Solution:</b> | Specify Renold Chain with extra hard surface materials to be included in the manufacture of chain round parts. |

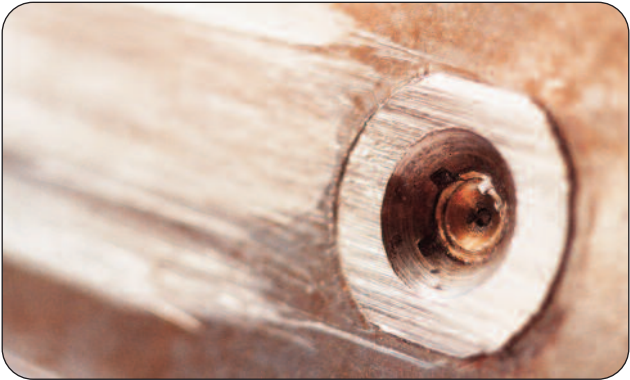
Figure 25 - Mode of Failure - Alignment

| Failure Mode: | Wear to the pin ends has removed the rivet security and the outer plate has become detached. |
| Diagnosis: | Differential wear to the chains has caused the vertical strands to move to the side and contact the guides. The guides are of similar hardness to the pin ends and the pin ends have worn away releasing the outer side plate. |

| Solution: | Fit side guides that are softer than the pin ends. Also consider fitting a rubbing block at intervals along the chain to protect the pin end. |

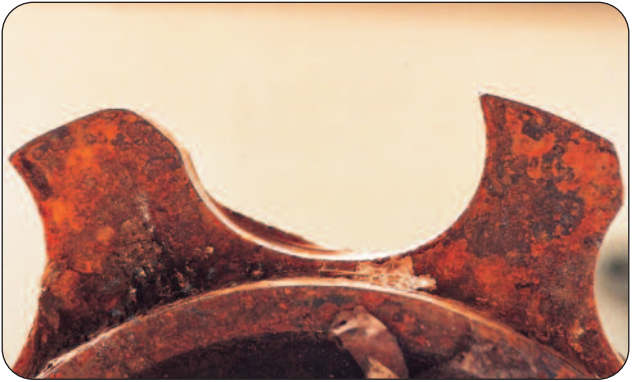
**Figure 26 - Mode of Failure - Alignment**

| <b>Failure Mode:</b> | Sprocket teeth suffered severe wear over a six month period and several teeth were so weakened that they fractured across the thinnest section. |
| <b>Diagnosis:</b> | The teeth were machined to a thinner section to accommodate flanged rollers on the chain and the chain was allowed to run out of line which resulted in only part contact on the sprockets. The resulting high pressure caused the rapid wear shown on the photograph. |

| <b>Solution:</b> | Replace the sprockets and realign the chain to ensure full contact between the chain roller and the sprocket teeth. |

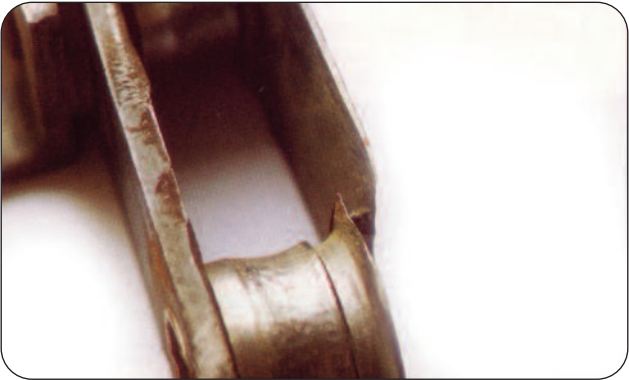
**Figure 27 - Mode of Failure - Alignment**

| <b>Failure Mode:</b> | Wear on the chain side plate has occurred and the side plate has failed under load. |
| <b>Diagnosis:</b> | The chain has been allowed to run out of line and the sprocket teeth have worn away one side plate to the point where the side plate became so thin it failed under load. |

| <b>Solution:</b> | The chain has been damaged beyond repair and must be replaced. Chain tracks must be checked and sprocket alignment corrected before operating with the new chain. |

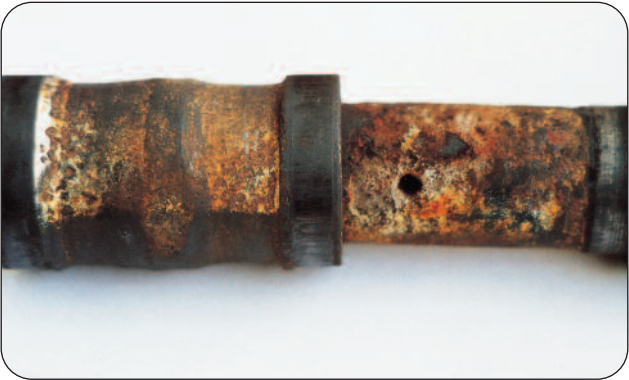
**Figure 29 - Mode of Failure - Corrosion/Erosion**

| <b>Failure Mode:</b> | Severe corrosion and wear of pin and bush surfaces. |

| <b>Solution:</b> | Replace the chain and ensure that the grease gun lubrication feature is regularly used. |
